# State of Utah DEPARTMENT OF NATURAL RESOURCES Division of Oil, Gas & Mining

# Inspection Report Minerals Regulatory Program April 16, 2013

Mine Name: Topaz Mine	Permit Number: M/023/0003	
Operator Name: Materion Natural Resources Company	Inspection Date: April 16, 2013	
Inspector(s): Paul Baker, Leslie Heppler, Lynn Kunzler, Peter Brinton	Time: 10:30 am till 12:30 pm	
Other Participants: John Wagner	Mine Status: ACT	
<b>Weather Condition</b> : Temperature in 30's strong winds and over cast skies	Last Inspection: April 12, 2012	
Bond Renewal Date: 12/01/2016	Bond Amount: \$1,398,000	
Surface Ownership: Fee	Mineral Ownership: Fee/SITLA	
Last Year of Production: 2013	Acreage: 271

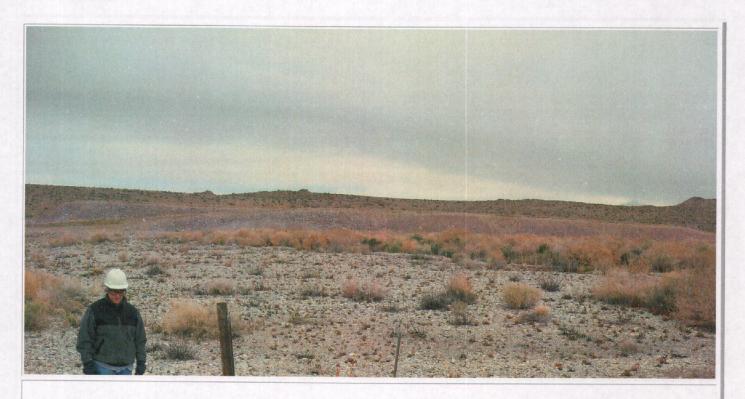
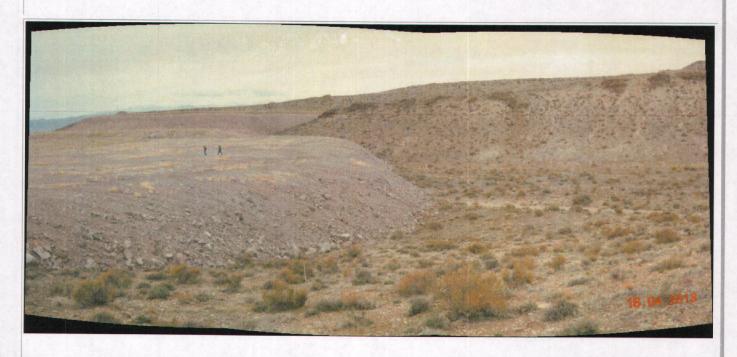
The Rainbow waste rock dump, built across an existing drainage with a defined channel, was inspected to determine whether the dump impounds stormwater. No signs of impoundment were visible. Mr. Wagner reports that

stormwater impoundment is rare and drains quickly through the dump and ground (as reported in the plan). Waste rock will continue to be dumped in this drainage and that the end result will be the lack of an impoundment.

Vegetation on topsoiled portions of the dump is progressing well with few weeds. Dominant species include crested wheatgrass, fourwing saltbush, and Palmer penstemon.

Stitched photo of the Rainbow waste rock dump
